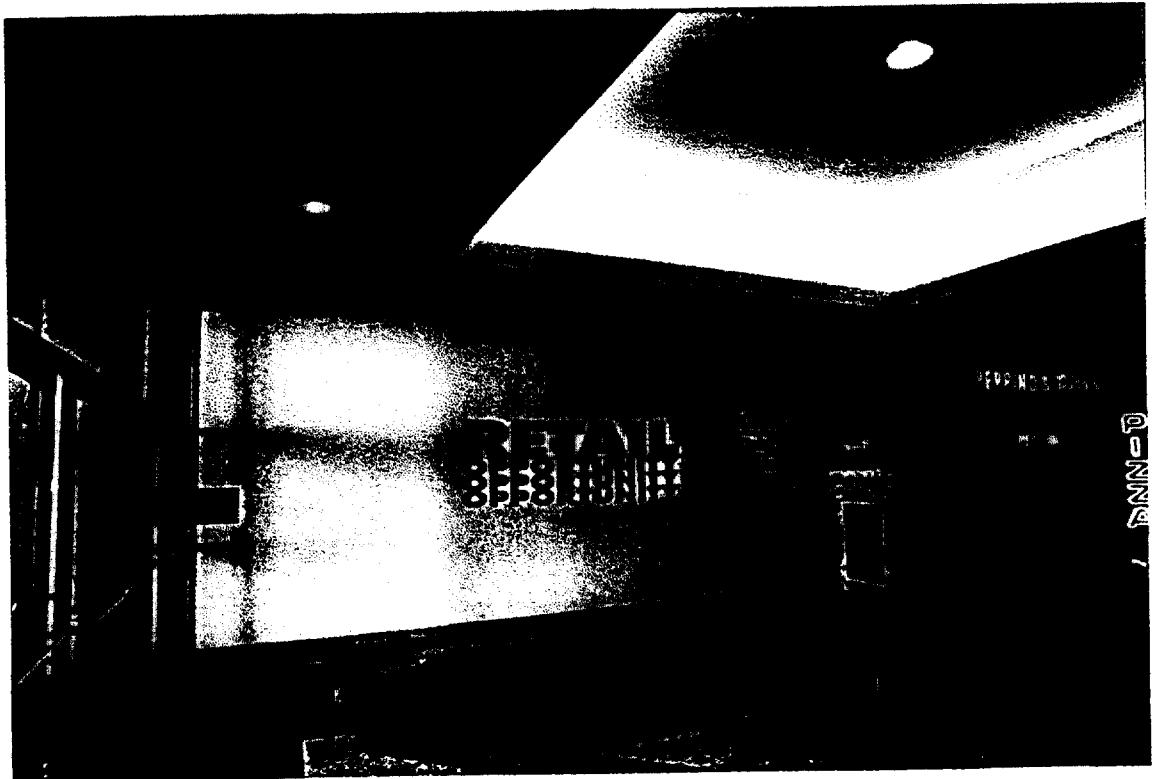
Indoor, shopping mall

Photograph: Test Location, 11 meters inside entrance
Location: Aurora Mall, Aurora (Denver)

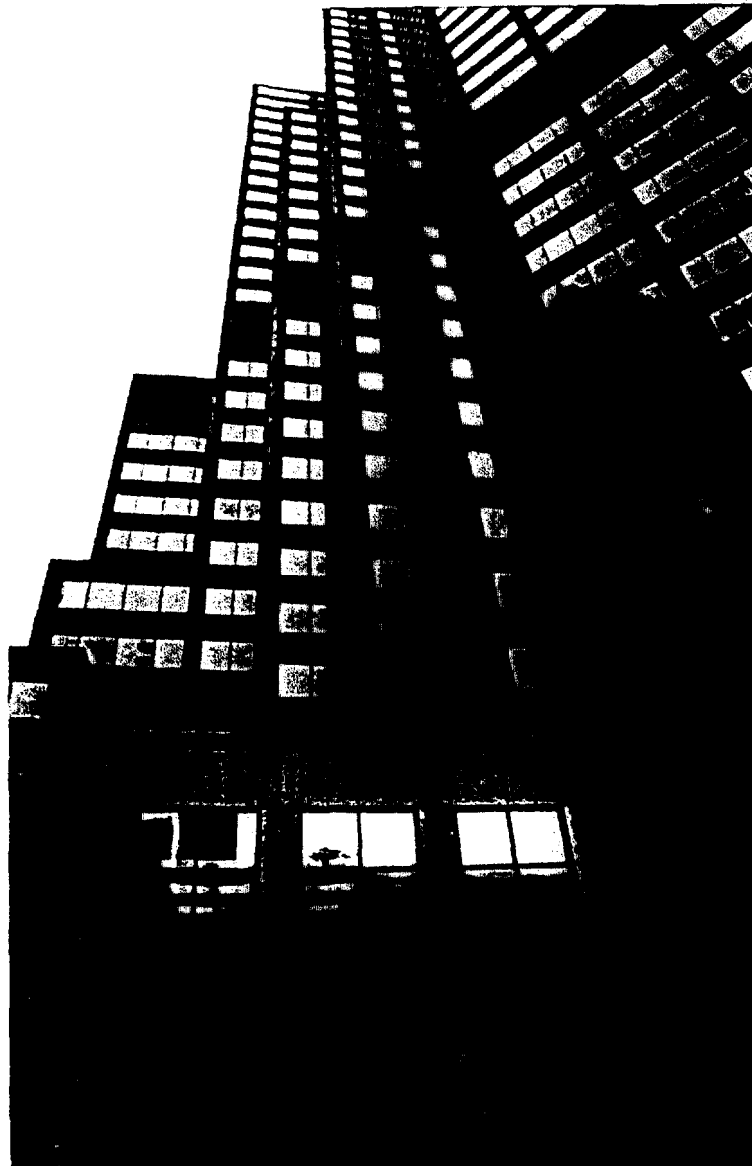
Indoor, 50-story office building (glass/steel)

Photograph: exterior view

Location: US West building, 1801 California, Downtown Denver

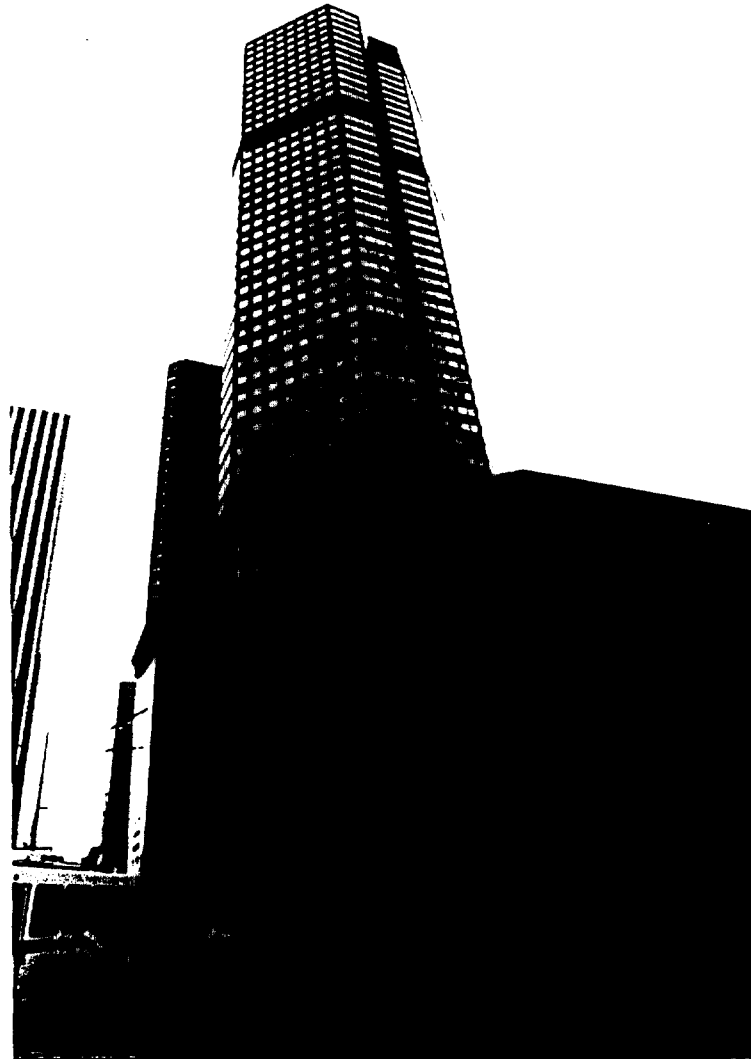
Indoor, 50-story office building (glass/steel)

Photograph: exterior view

Location: US West building, 1801 California, Downtown Denver

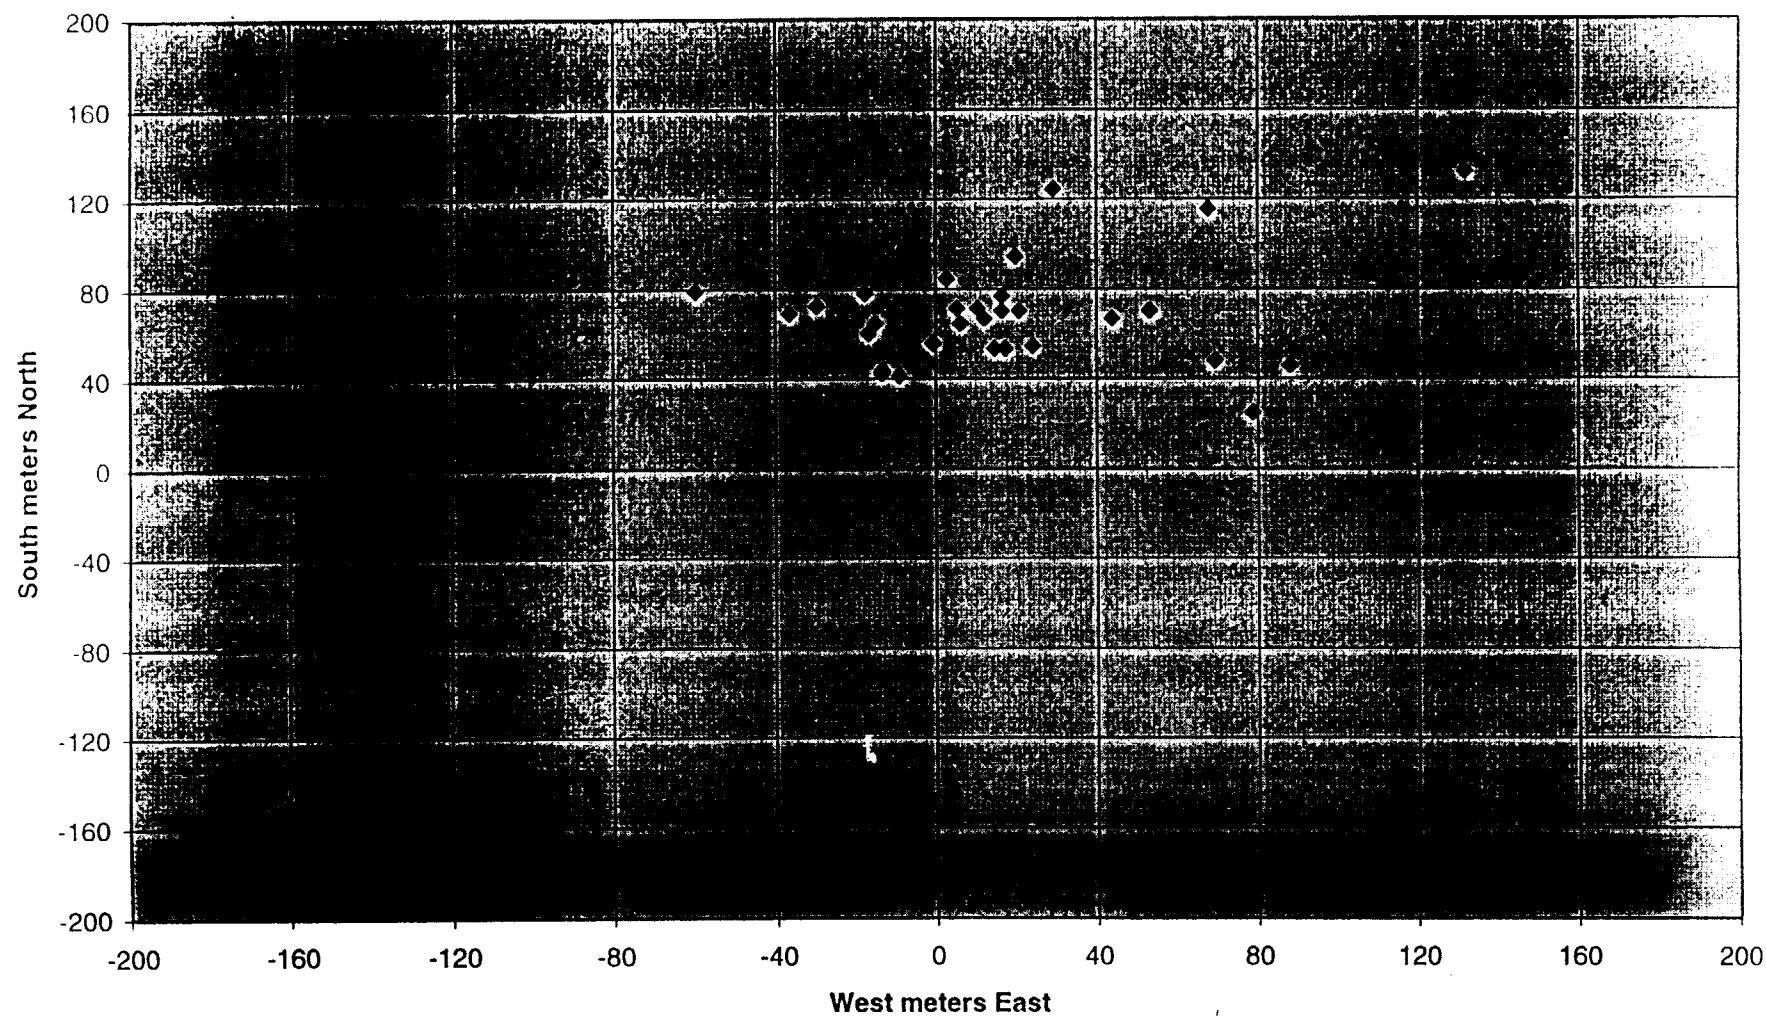
Indoor, 50 story office building (glass / steel)

US West Building, 1801 California, Downtown Denver

Test location #1, 21st Floor, 4.4 Meters from exterior wall

Single fix results

Yield: 32 of 36 (89 %)

68.3% Horizontal CEP: 84.3 Meters

Max Horizontal Error: 231.2 Meters

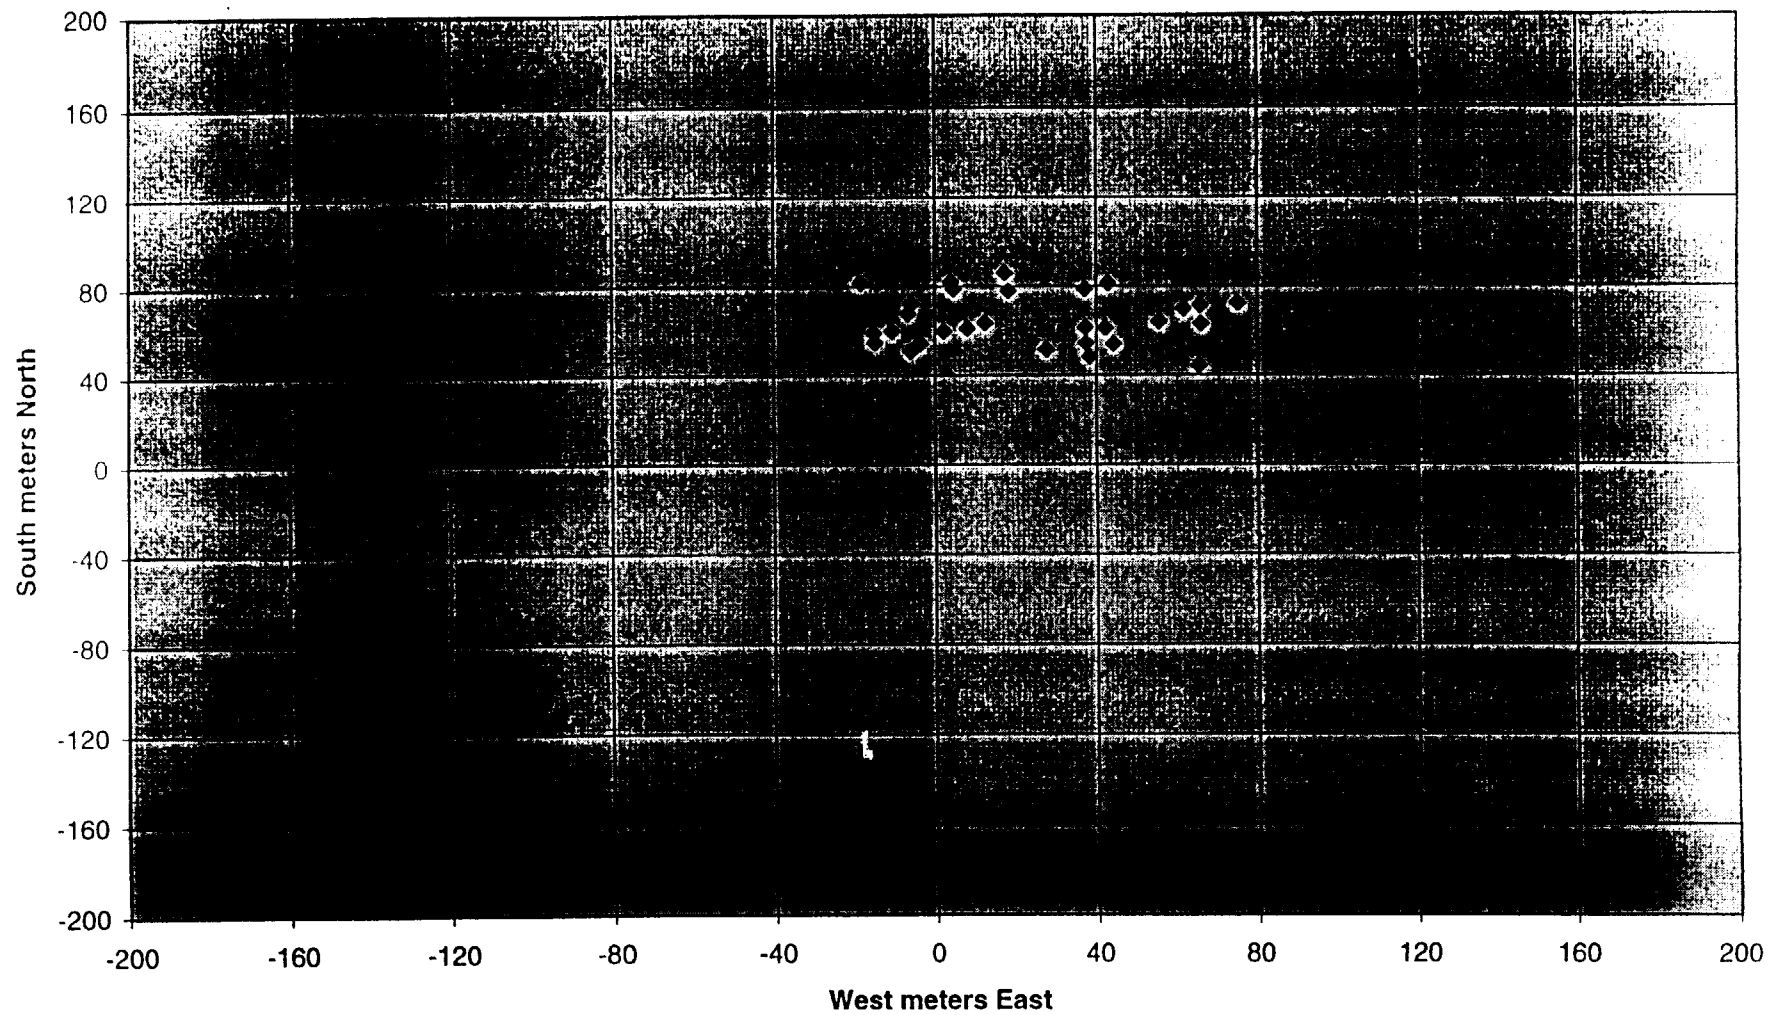
Indoor, 50 story office building (glass / steel)

1801 California, Downtown Denver

Test location #1, 21st Floor, 4.4 Meters from exterior wall

5 point averaging results

Yield: 32 of 32 (100 %)

68.3% Horizontal CEP: 82.4 Meters

Max Horizontal Error: 104.4 Meters

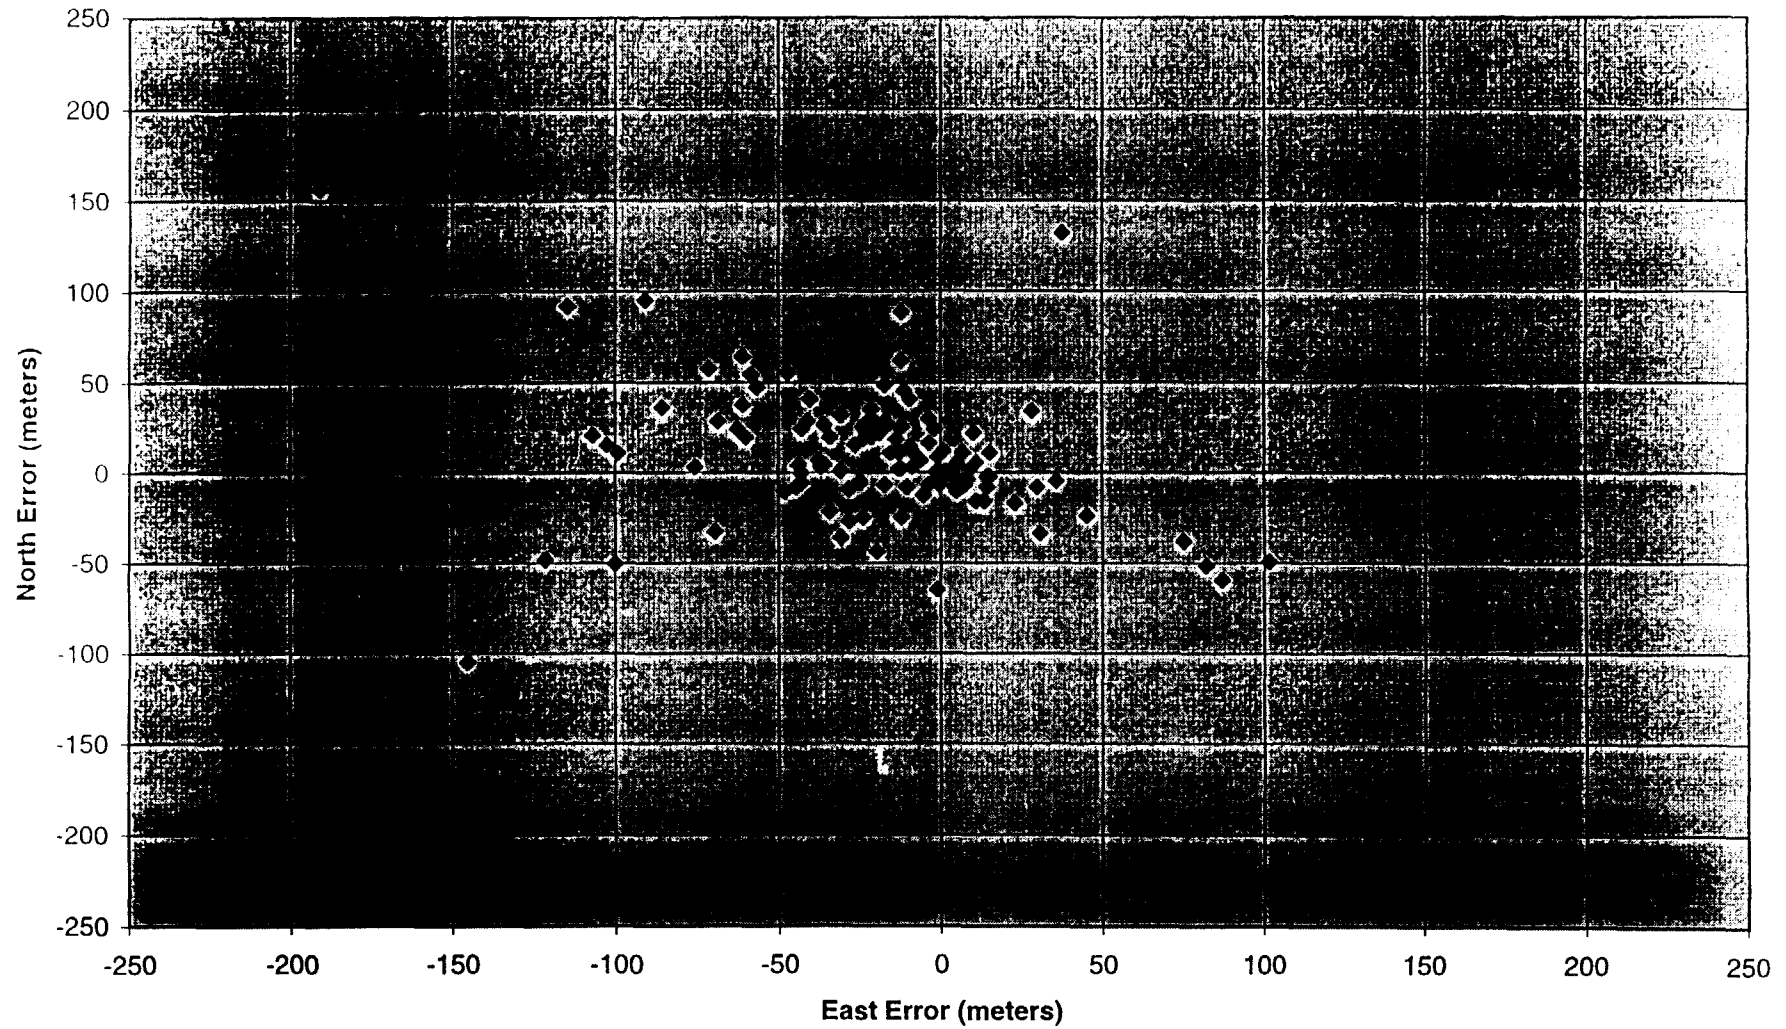
Outdoor, Urban Canyon street level (mid block)
Curtis street between 16th and 17th, Denver

Single fix results

Yield: 120 of 120 (100 %)

68.3% Horizontal Error: 45.4 Meters

95% Horizontal Error: 112.7 Meters

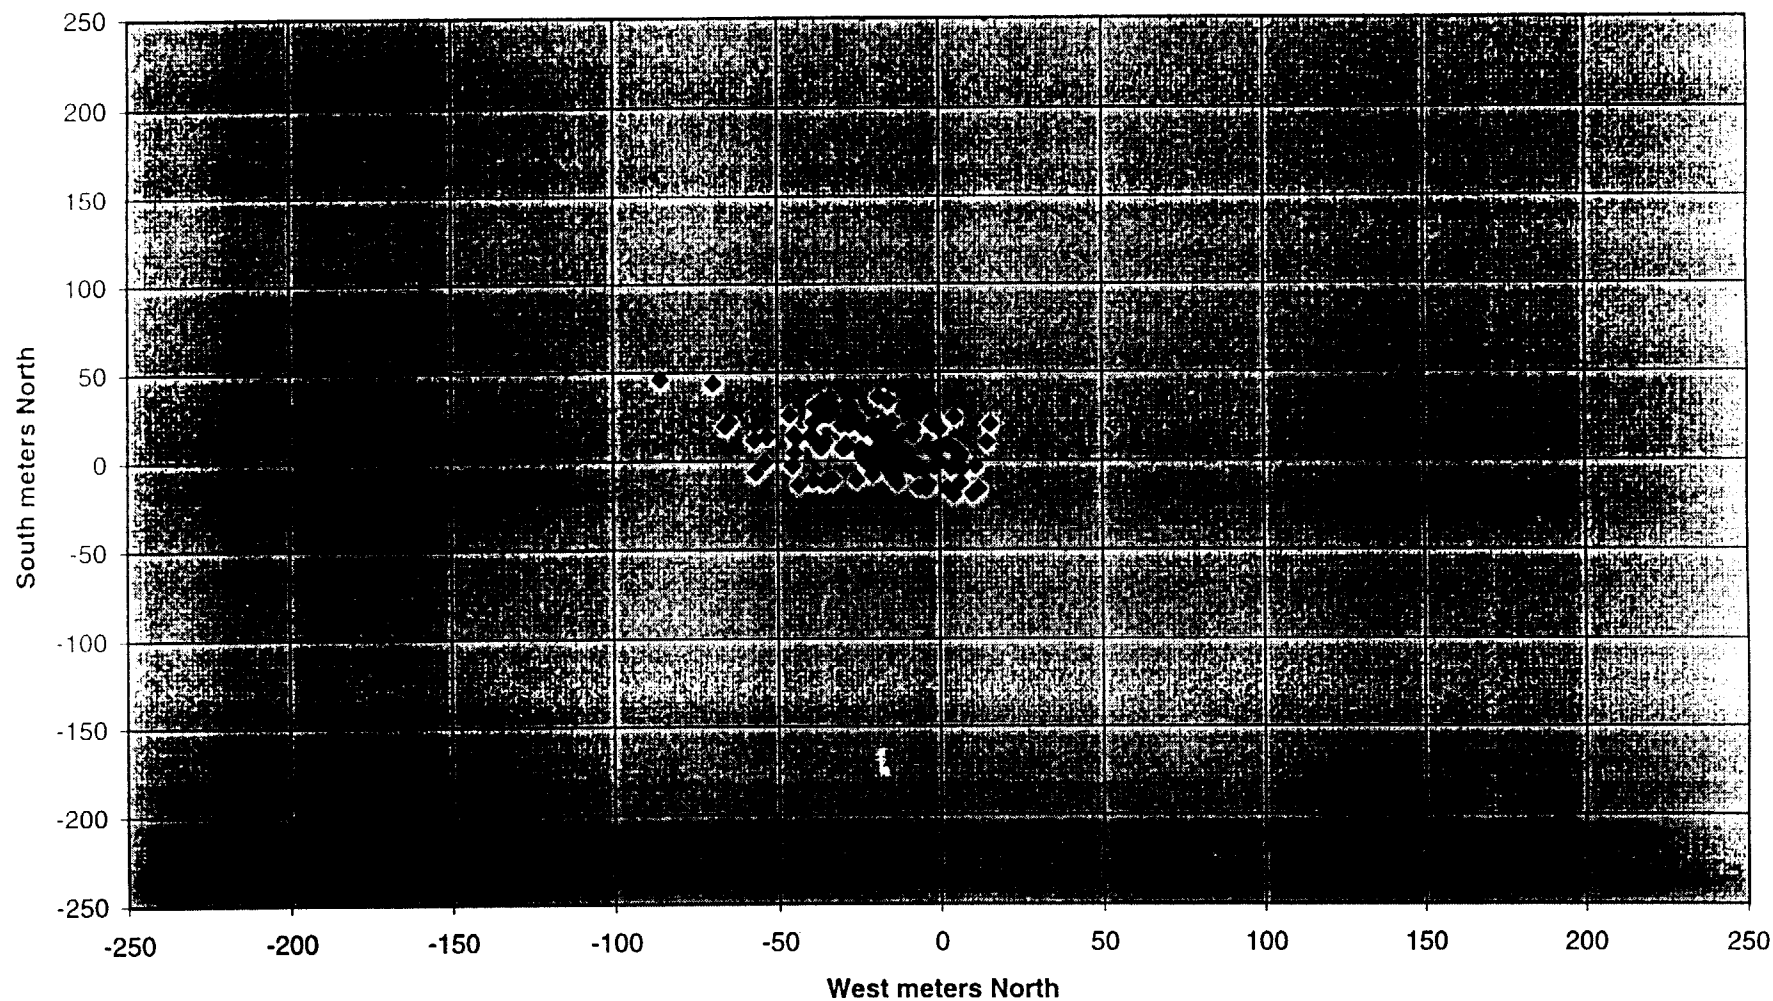
Outdoor, Urban Canyon street level (mid block)

Curtis street between 16th and 17th, Denver

5 point averaging results

Yield: 116 of 116 (100 %)

68.3% Horizontal Error: 36.6 Meters

95% Horizontal Error: 55.0 Meters

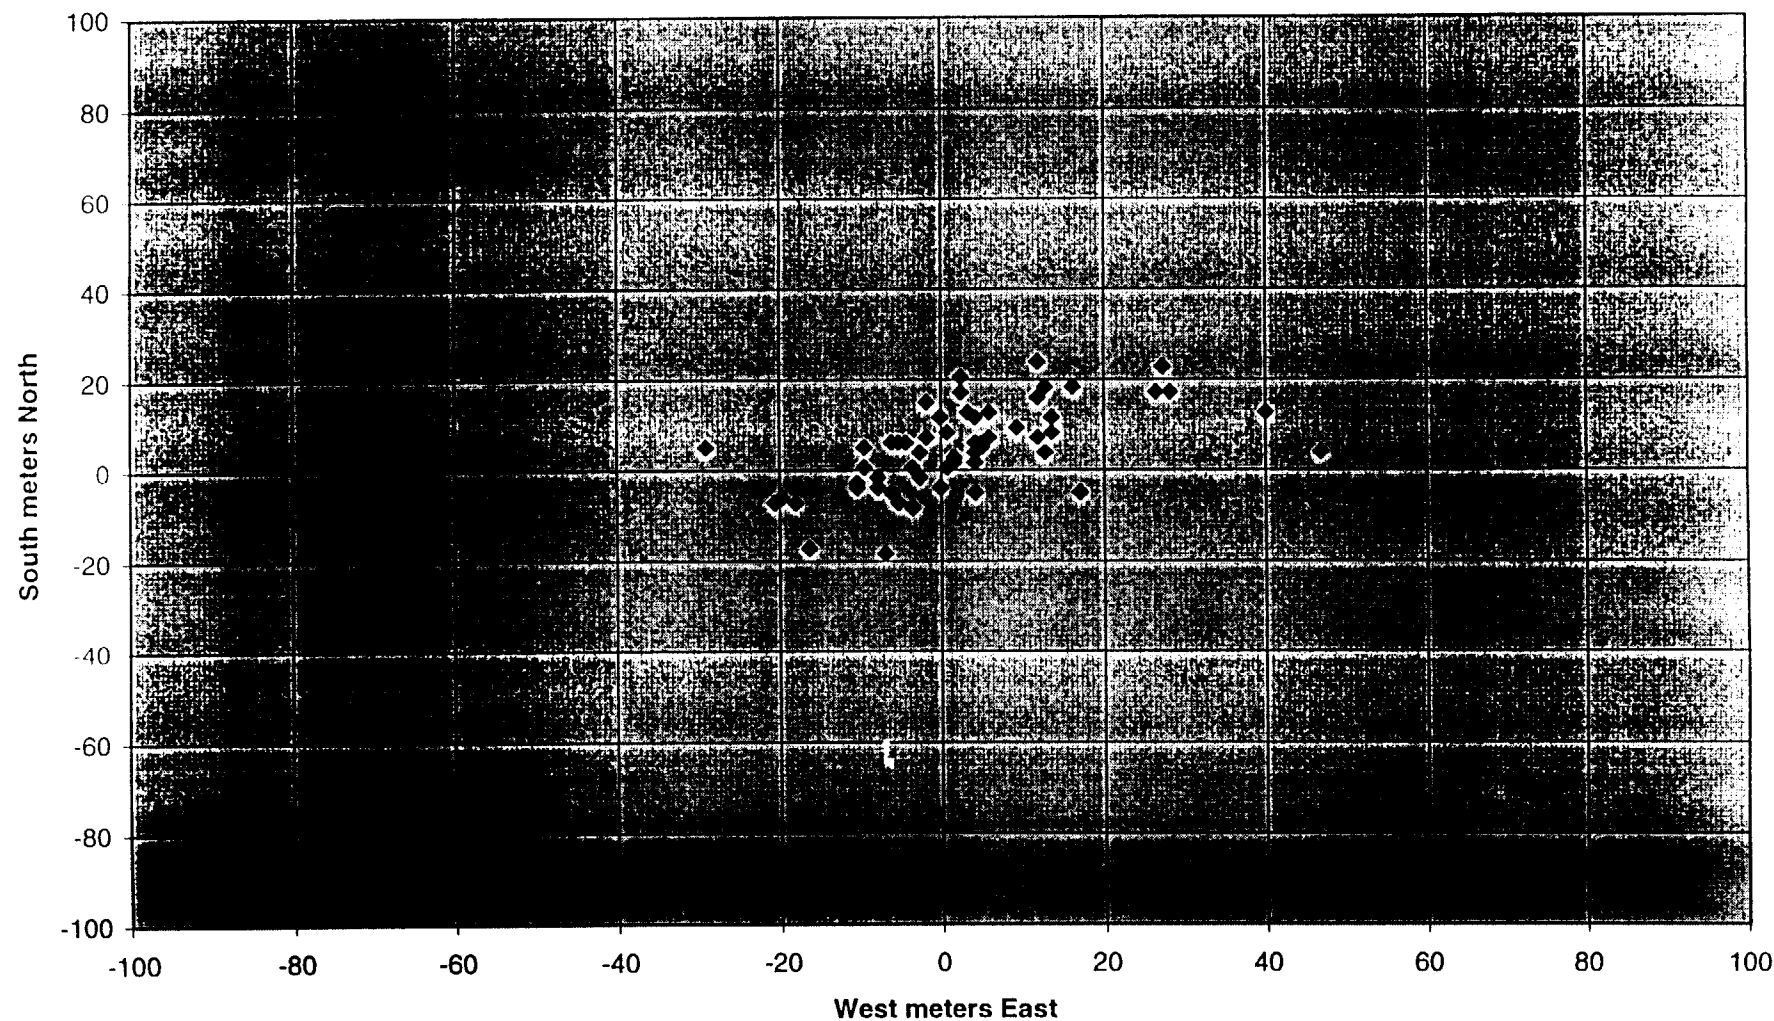
Outdoor, urban canyon

Parking garage adjacent to US West building, 1801 California

Downtown Denver

Test location is on top floor

Single fix results

Yield: 57 of 57 (100%)

68.3% Horizontal CEP: 17.5 Meters

Max Horizontal Error: 47.1 Meters

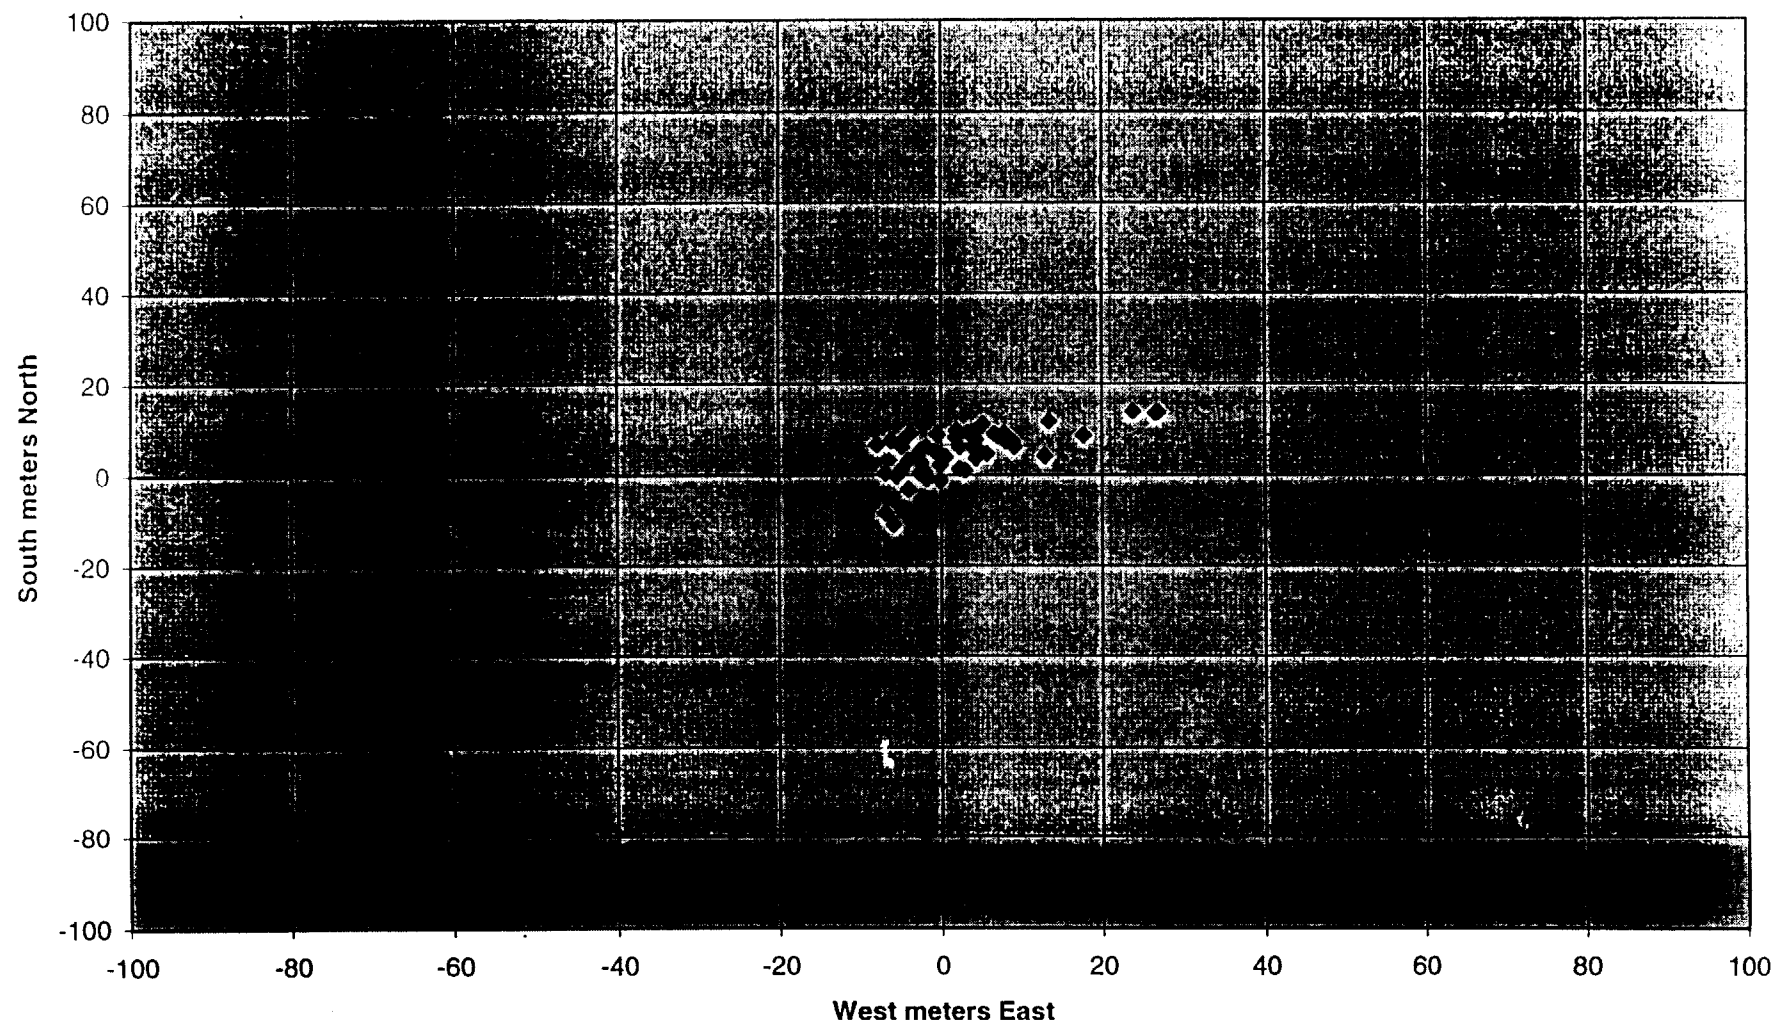
Outdoor, urban canyon

Parking garage adjacent to US West building, 1801 California

Downtown Denver

Test location is on top floor

5 point averaging results

Yield: 53 of 53 (100%)

68.3% Horizontal CEP: 10.4 Meters

Max Horizontal Error: 30.2 Meters

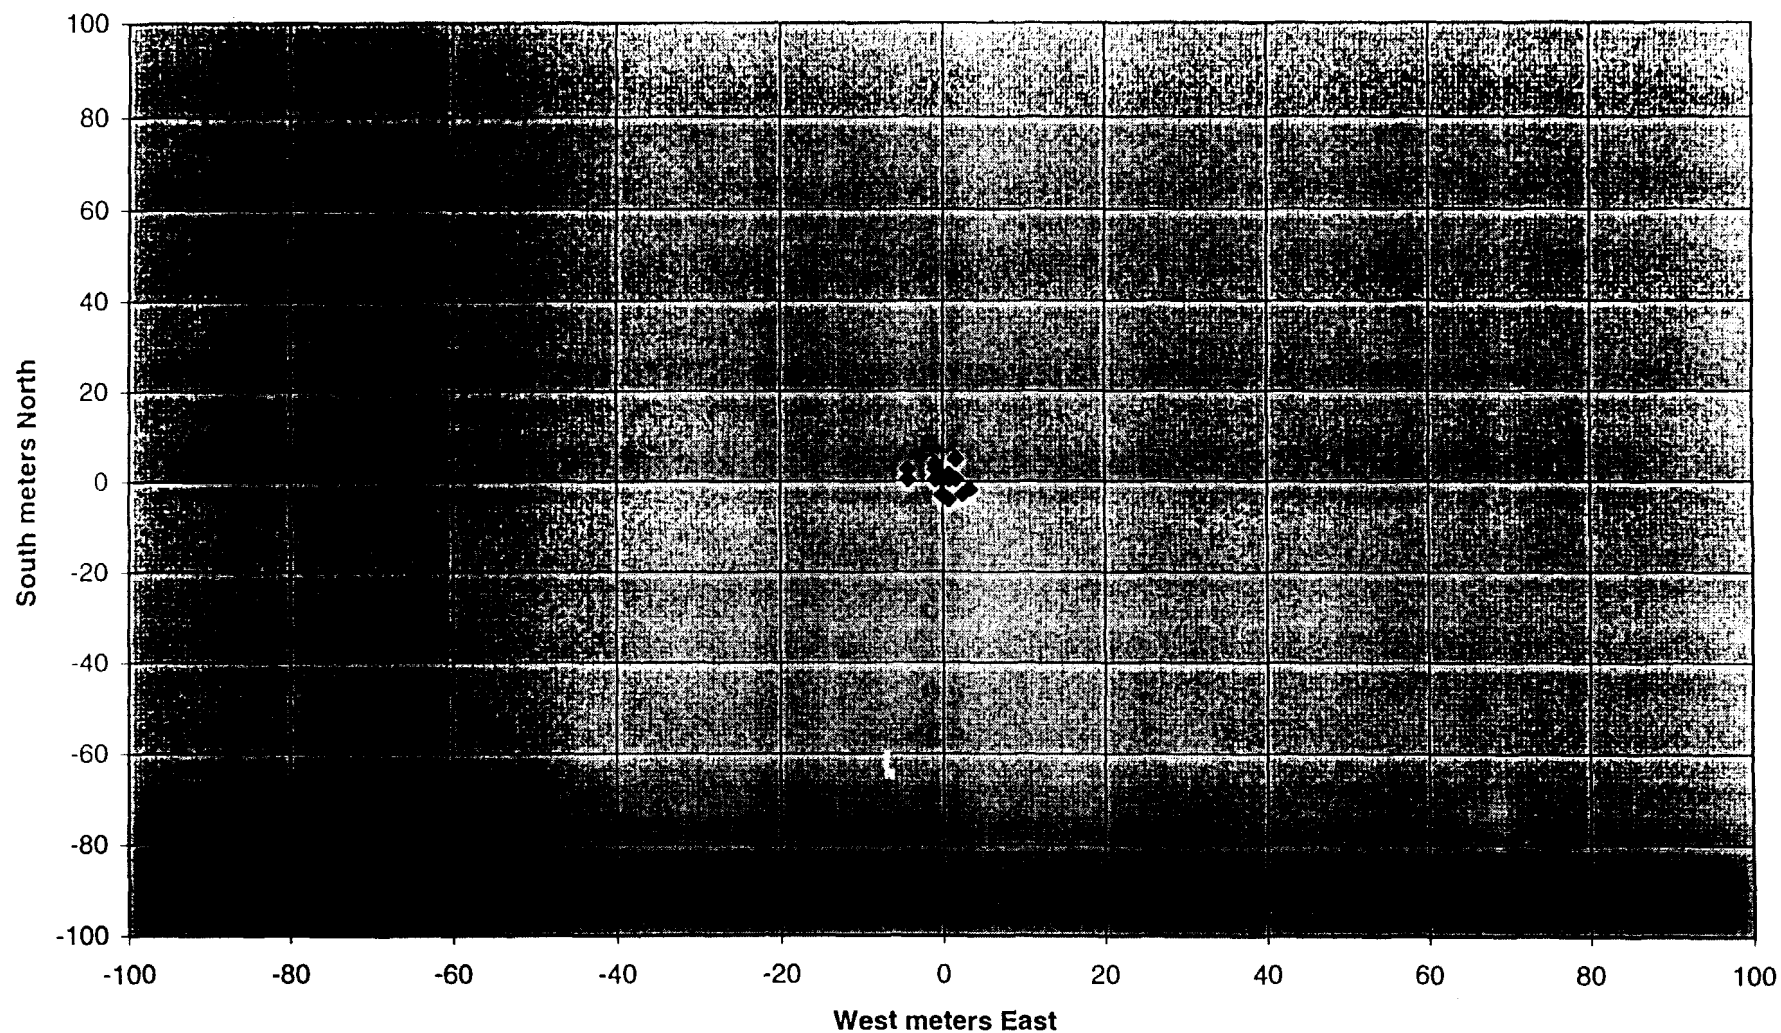
Outdoor, open site

Test location, 71st and Winchester Circle

Boulder, Colorado

(no independent ground truth)

Single fix results

Yield: 16 of 16 (100 %)

68.3 % Horizontal CEP: 3.9 Meters

Max Horizontal Error: 5.2 Meters

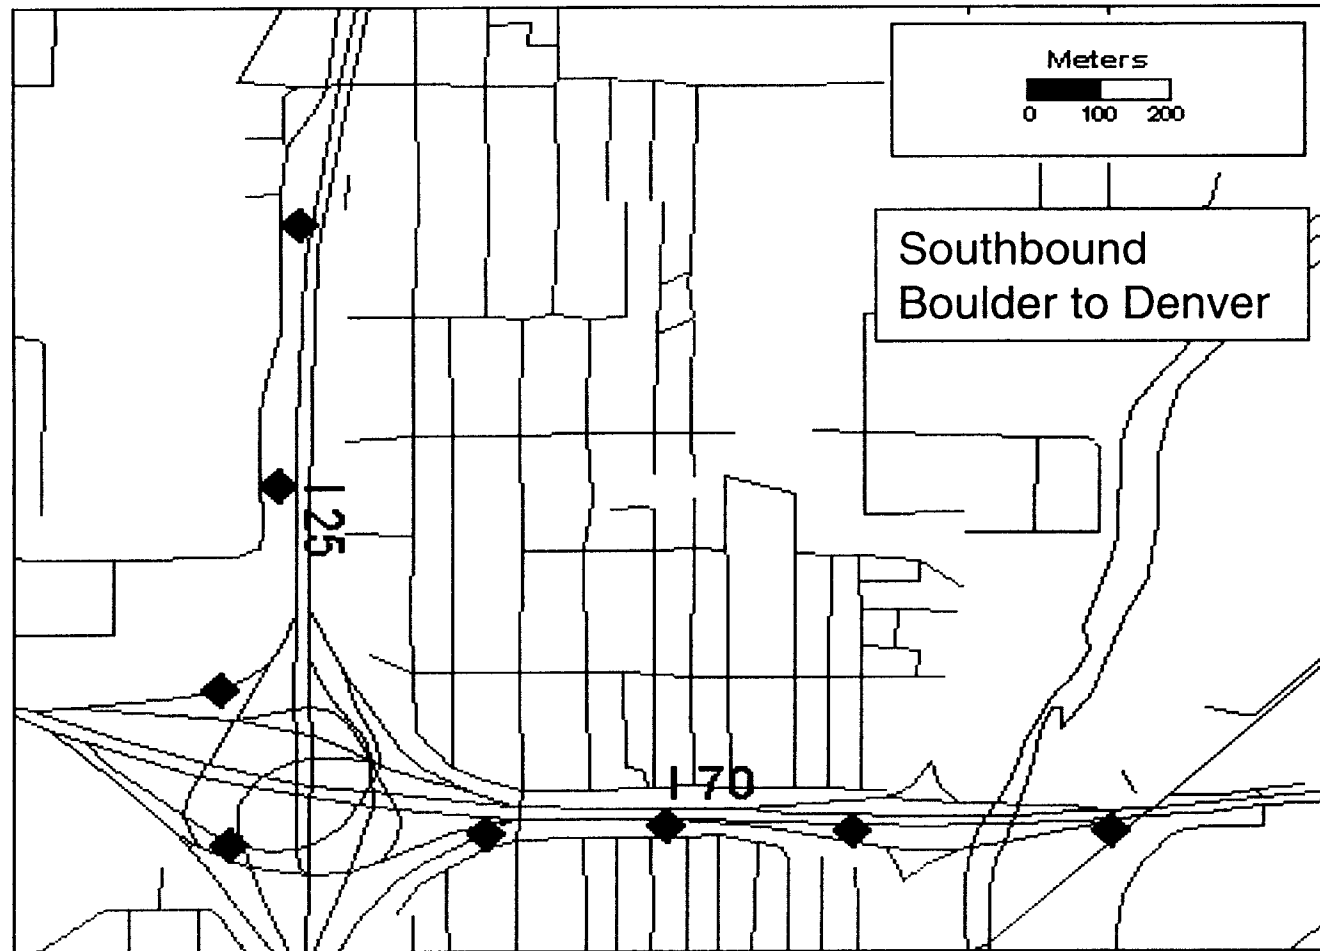
Audited Drive Test: Urban Highway

Antenna on Left Shoulder of Front Passenger

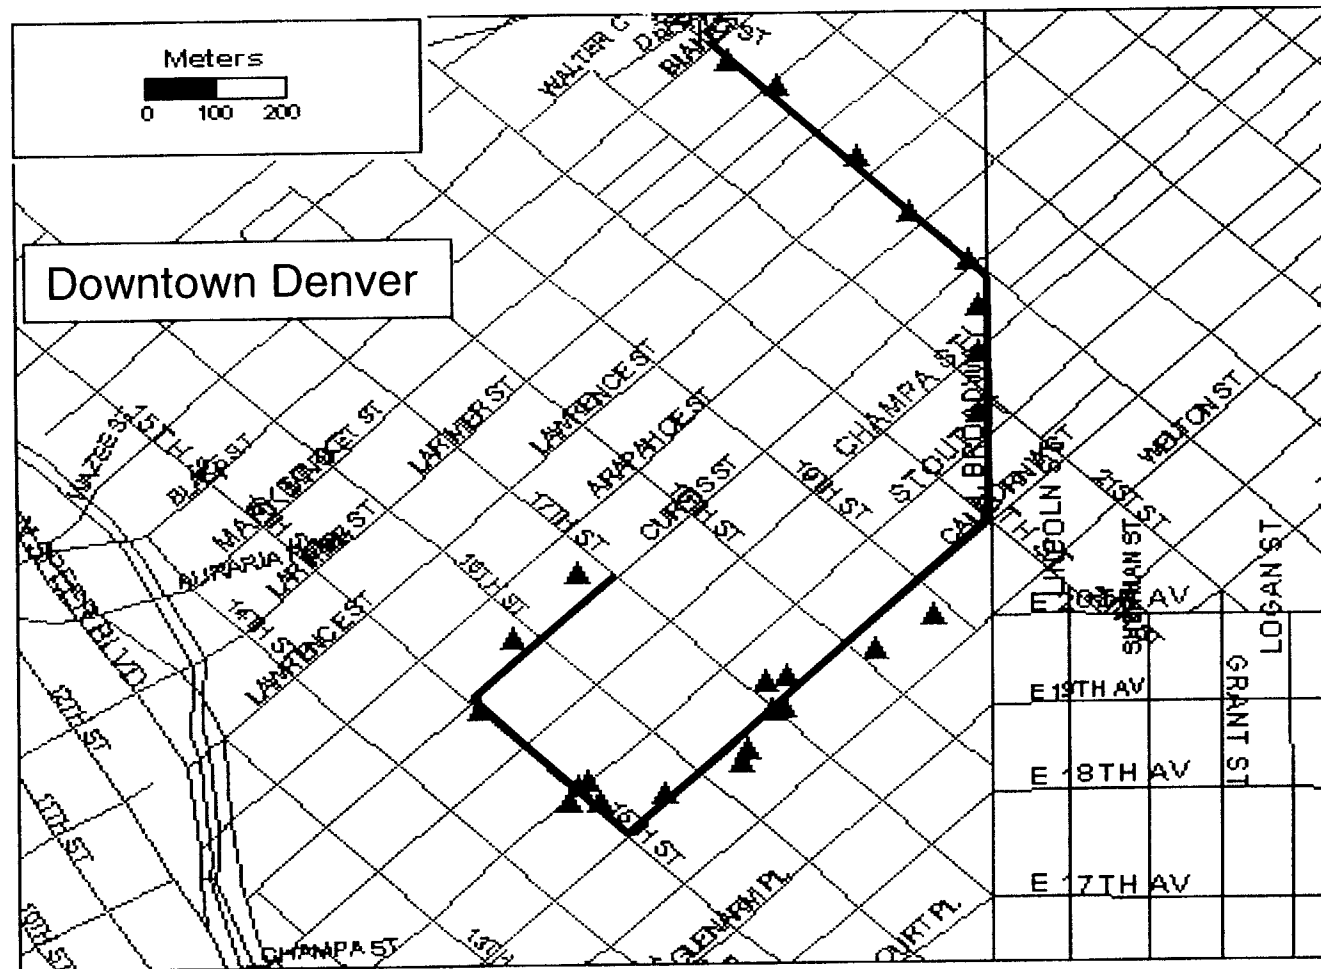
Audited Drive Test: Urban Canyon

Antenna on Left Shoulder of Front Passenger
